AN ENGINEERING GEOLOGICAL INVESTIGATION
OF BATTER STABILITY
WEAVERS OPENCAST COAL MINE - HUNTLY

A thesis
submitted in partial fulfilment
of the requirements for the Degree
of
Master of Science in Engineering Geology
in the
University of Canterbury
by
Udo Wezenberg

University of Canterbury
1988

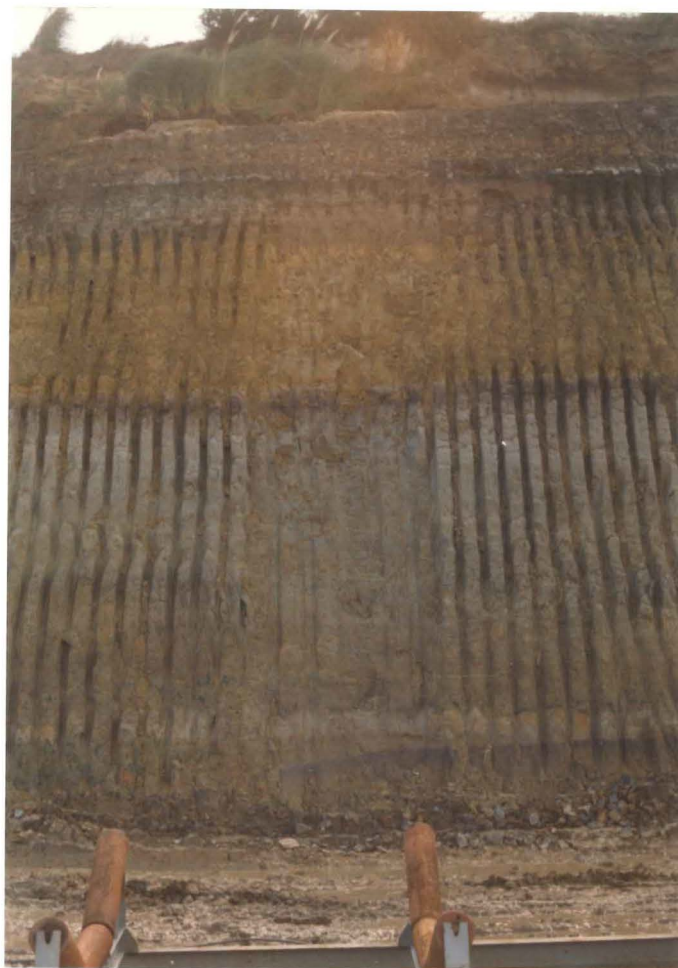
Figure 2.5: Paleochannel incised into Whangamarino Formation clayey silts,
 (G.R. 333520mE 623580mN) viewing east.
 A: stiff clayey silts of Whangamarino Formation;
 B: gravelly sand lens grading up into sandy silt;
 C: iron staining at base of channel indicating water seepage;
 D: piping failures in Hinuera Formation.

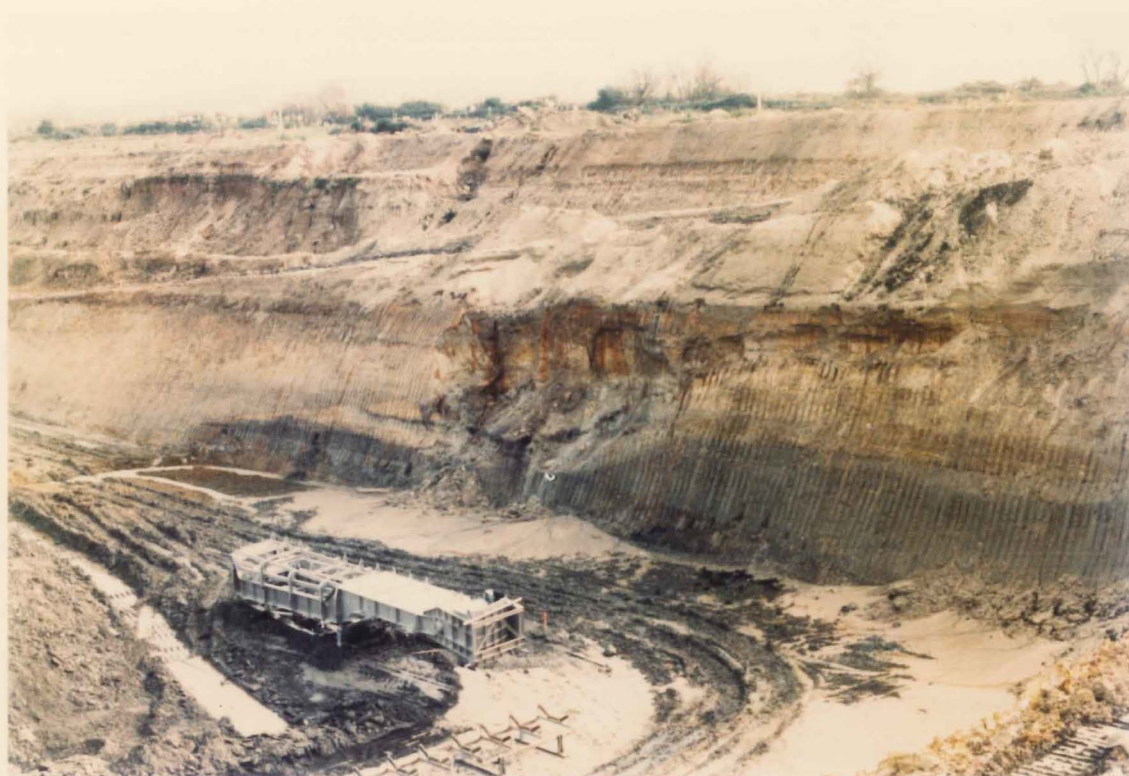
Figure 2.6: Paleochannel incisions into Whangamarino Formation, (G.R.333465mE 623575mN) viewing north.

Incised into the silty clays of the Whangamarino Formation are gravelly sand and sandy silt lenses (Figures 2.5 and 2.6). These occur extensively in the northeastern batter slopes where they are thought to indicate evidence of significant stream incision into the upper Whangamarino Formation during the degradational period that followed the units deposition (Kear & Schofield 1978). Similar channel structures were observed in the Whangamarino Formation in the southwestern batter slopes, immediately above the June 1986 batter failure (section 4.2.2.5).

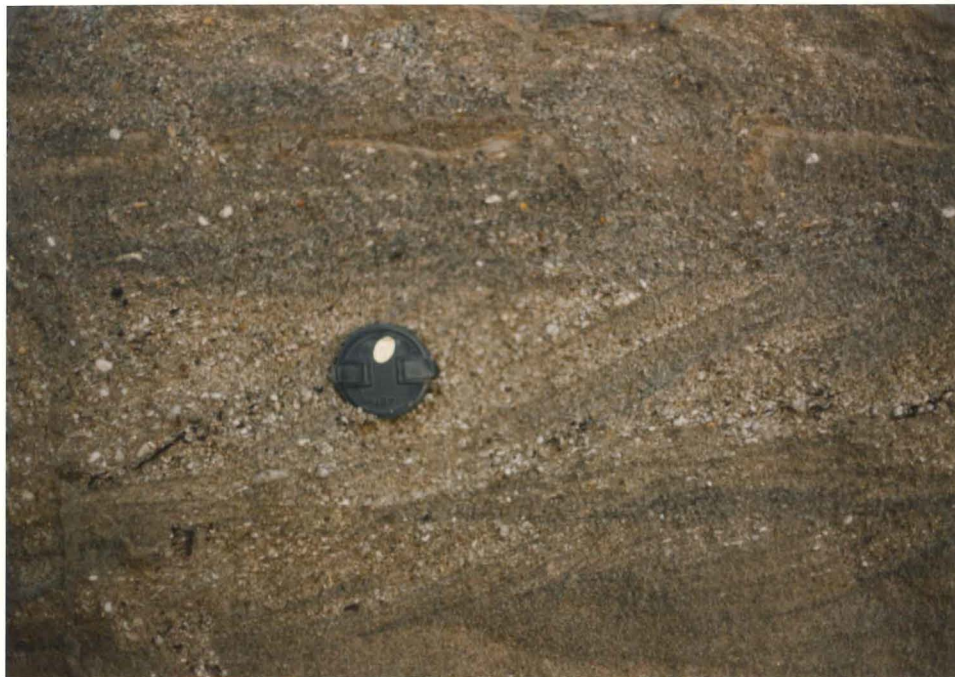
Figure 2.7: Hinuera Formation loose pumiceous current bedded gravelly sands. Lens cap for scale (50mm).

The dominant lithology (Figure 2.7) consists of loose current bedded, yellowish brown to grayish green, gravelly sands and sandy gravels, fining upwards into medium to fine sand and sandy silts. Alldred (1984a) described the occurrence of three clay layers in the Hinuera Formation that stand out in the batter face. The upper clay layer is 0.2-0.6m thick and marks the boundary with overlying Taupo Pumice Alluvium, it is situated at a constant R.L. of +5m and consists of light blue grey, wet, highly plastic, very fine silty clay. A second identical clay layer is situated at +3m R.L. and a third can be identified at the base of the Hinuera Formation (-1m to -3m R.L.) where it unconformably overlies the Whangamarino Formation. The clay bands are continuous over the length of the batter face until but are eroded from the sequence in the southwest of the mine area. (Cross Section Figure 1 Map Pocket)

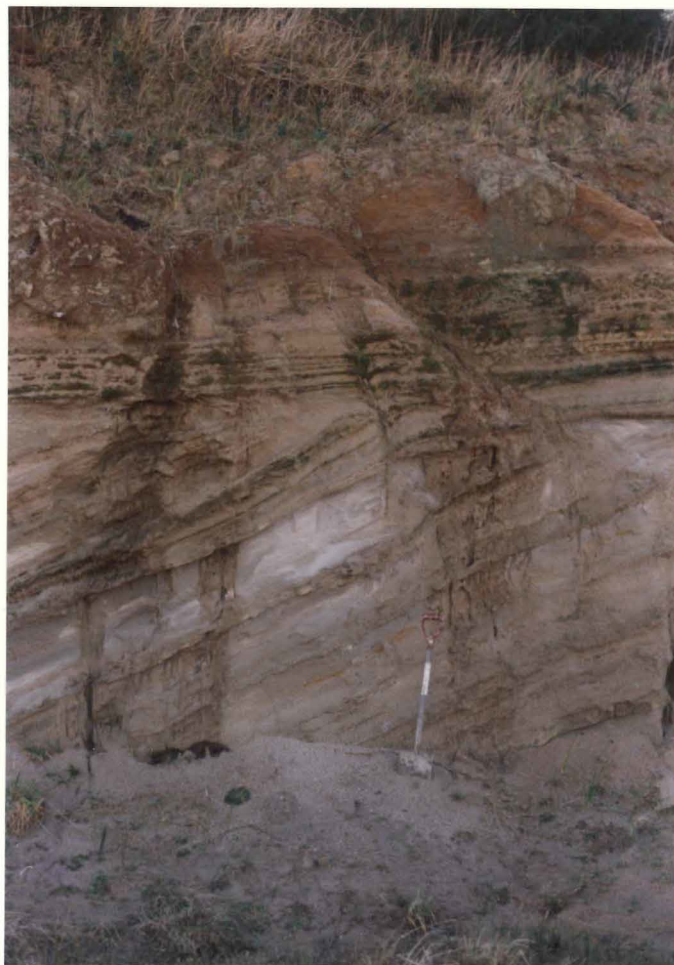
Figure 2.8: Taupo Pumice Alluvium; illustrating large scale (2m) current bedding. (G.R. 332950mE 623380mN) viewing north.

The unit has two sub members (Kear & Schofield 1978), (Figure 2.8), i) a lower member, of fluviatile, loose, creamy white, highly pumiceous quartzose, silt, sand, and gravel layers, interbedded with numerous charcoal fragments, up to 4m thick, with large scale foreset bedding; and ii) an upper member consisting of loose, creamy white, highly pumiceous, quartzose silty sands and gravelly sands, interbedded with charcoal fragments, it is up to 2m thick with current bedding on a scale of 10-20cm. In the northeast and central mine areas the Taupo Pumice Alluvium overlies the Hinuera Formation. In the southwestern part of the mine area the Hinuera Formation has been removed by erosion and the Taupo Pumice Alluvium unconformably overlies the Whangamarino Formation.

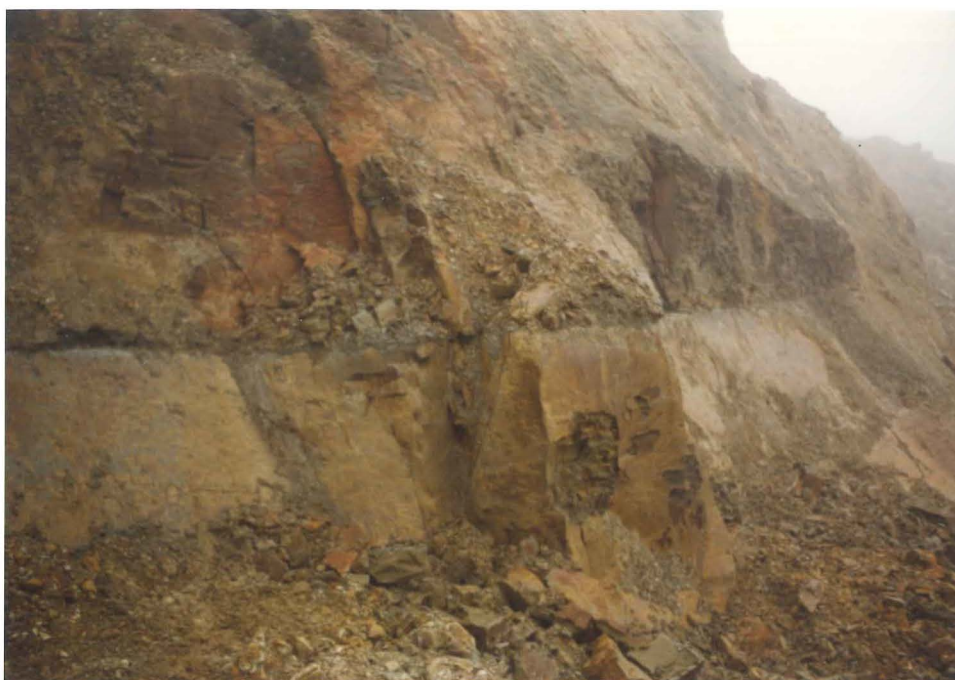
Figure 2.13: Weak highly persistent (40m+) clay layer in Glen Afton Claystone.
G.R. 333015mE 623330mN, viewing east
3m above contact with Waikato Coal
Measures. Dip is c.10 into batter face.

Engineering geological mapping identified the presence of weak highly persistent clay layers in the Glen Afton Claystone 2-3m above its contact with the Waikato Coal Measure succession. Two such shear zones were observed, the first (Figure 2.13), dips into the batter face at 10°, sub parallel to bedding of the underlying Te Kuiti Group sequence, and can be traced over 40m along the batter beyond which it

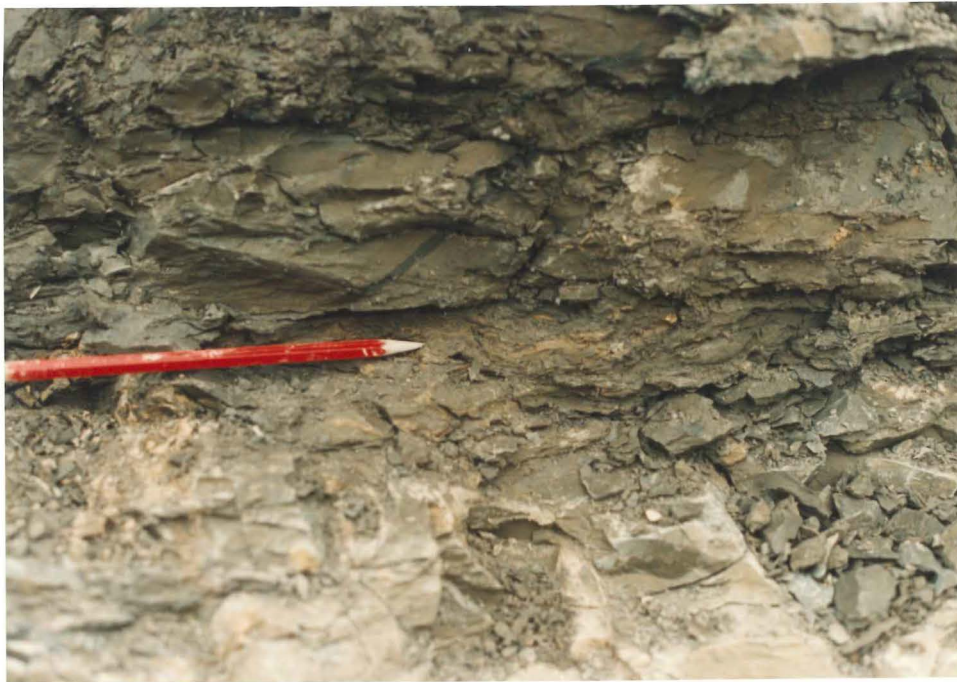
Figure 2.15: Shear gouge clay layer in Glen Afton Claystone, western batter slope 3m above contact with Waikato Coal Measures. (G.R. 332850mE 623135mN) viewing west.

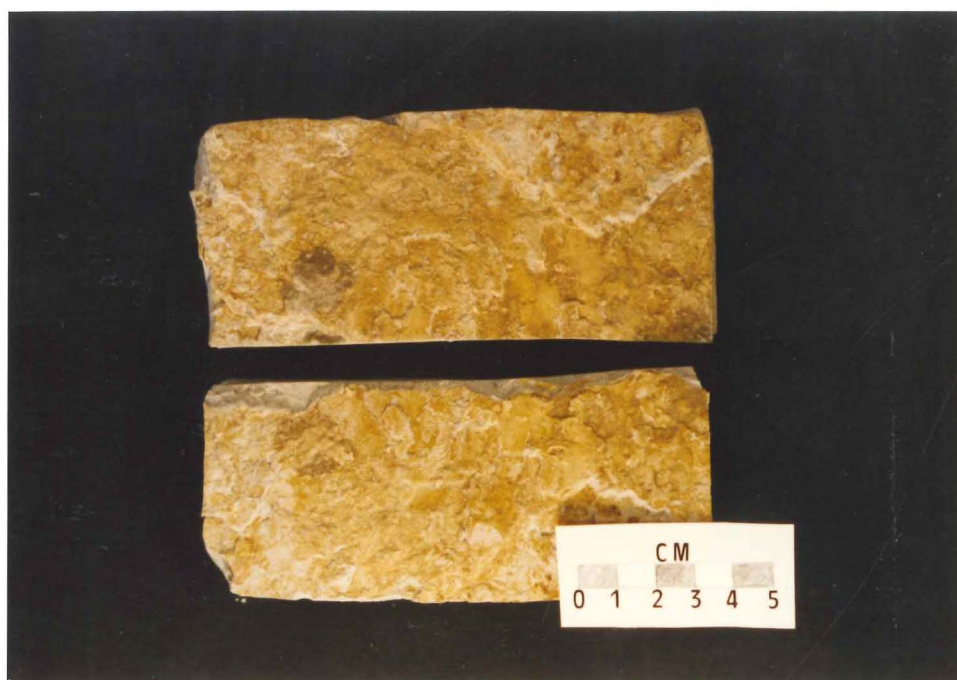
Figure 2.17: Plan view of bedding plane surface in a block sample collected from the Whangamarino Formation, illustrating oxidised appearance of bedding plane defects. The surface asperities present across the surface are up to 3mm high.

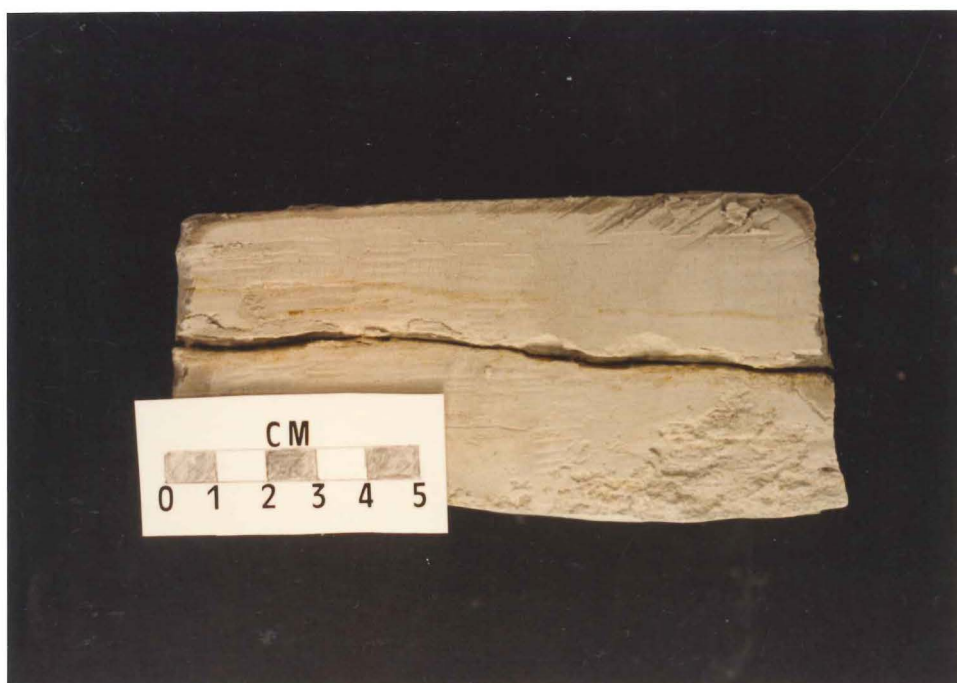
Figure 2.18: Cross sectional view of bedding plane surface in block sample (Fig. 2.17), illustrating amplitude of waviness along the bedding plane surface.

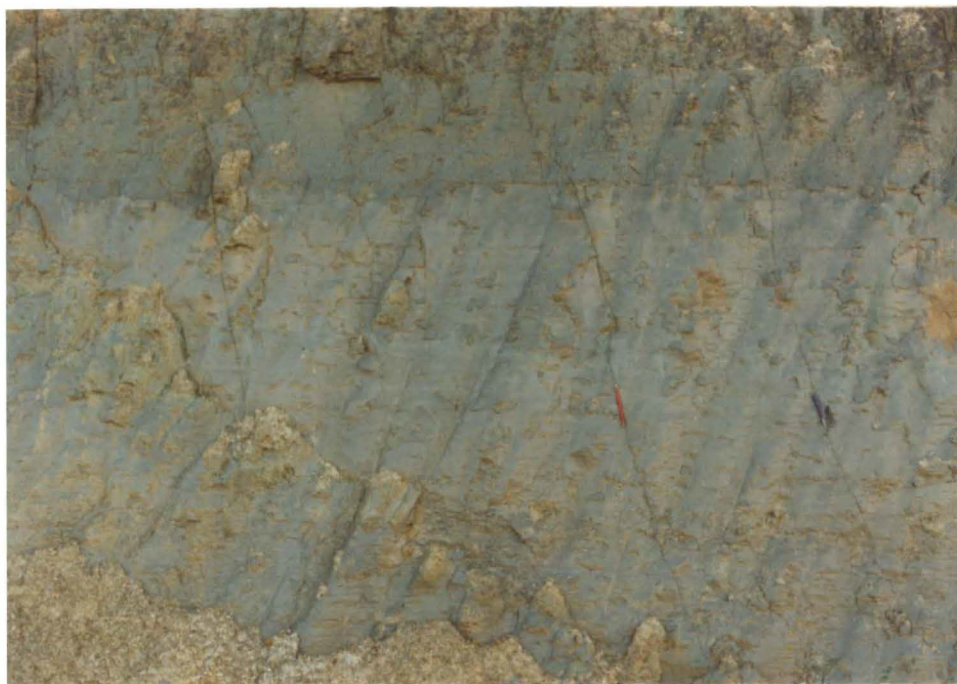
Figure 2.19: Sub vertical joint set in Whangamarino Formation clayey silts striking parallel to highwall, as observed in eastern batter slopes, (G.R. 333560mE 623550mN) viewing east.

Two sub vertical joint sets are identified; joint set, (defect set Z), strikes 060° - 240° parallel to the highwall orientation parallel to the highwall orientation (Figure 2.19). Dip angles are $90^{\circ} \pm 5^{\circ}$ towards 330° and 150° . The second joint set (Y) strikes 160° - 340° , almost at right angles to the highwall. Dip angles are sub vertical towards 070° and 250° respectively. Joints are continuous over the thickness of the unit and have a spacing of between 0.5-2m. Apertures are tight but joint surfaces are commonly oxidised. Joint surfaces show asperities of 2-3mm in height with wavelengths of several centimetres.

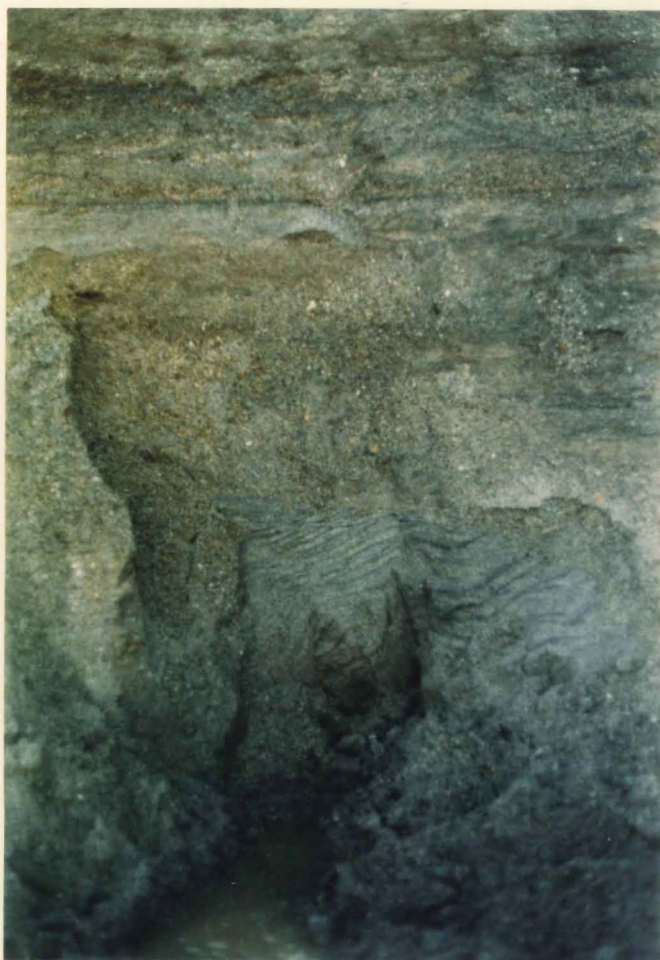
Figure 2.21:
Groundwater discharge into the pit at the base of the Hinuera Formation where it overlies a low permeability clay layer, 2 days after a period of heavy rainfall.

- i) Drainage of water from the Upper and Lower Aquifer units (Figures 2.21 and 2.22) The area of batter slopes over which the Upper Aquifer was exposed during the research period is approximately 6400m^2 (800m long by 8m thick) and for the Lower Aquifer is 960m^2 (120m long by 8m thick). Hue & Delahunty (1986) have measured water inflow from the aquifer by gravity drainage into the pit as 10 l/sec. and 2 l/sec. respectively.
- ii) Surface runoff from precipitation.

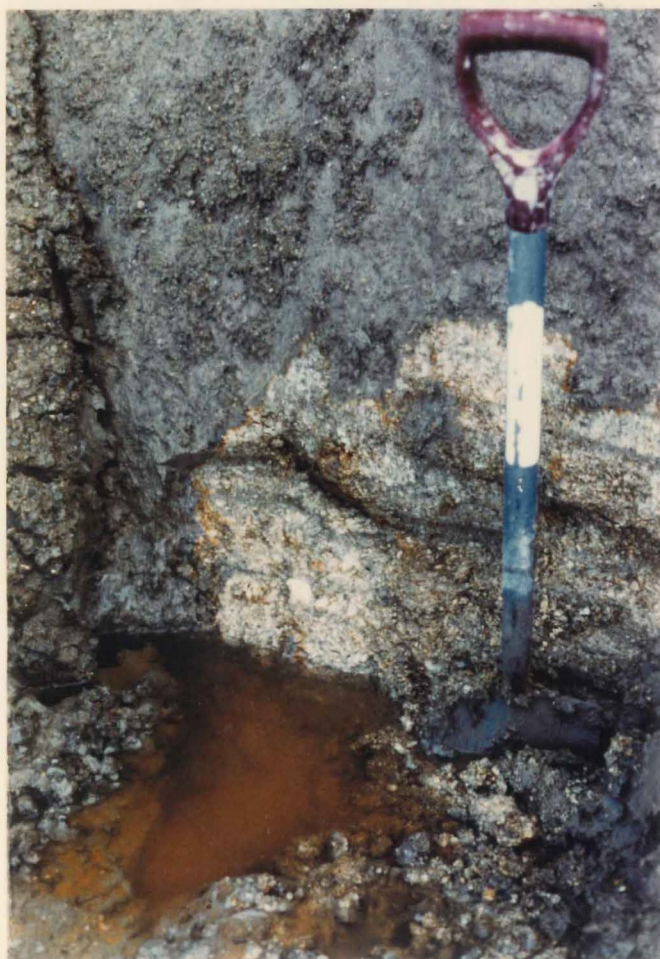
Figure 2.22:
Groundwater discharge into the pit from the Lower Aquifer. The puddle at the base of the batter formed in 20 seconds. Also observe the compact nature of the greywacke gravels and pumiceous sands and silts exposed in the face.

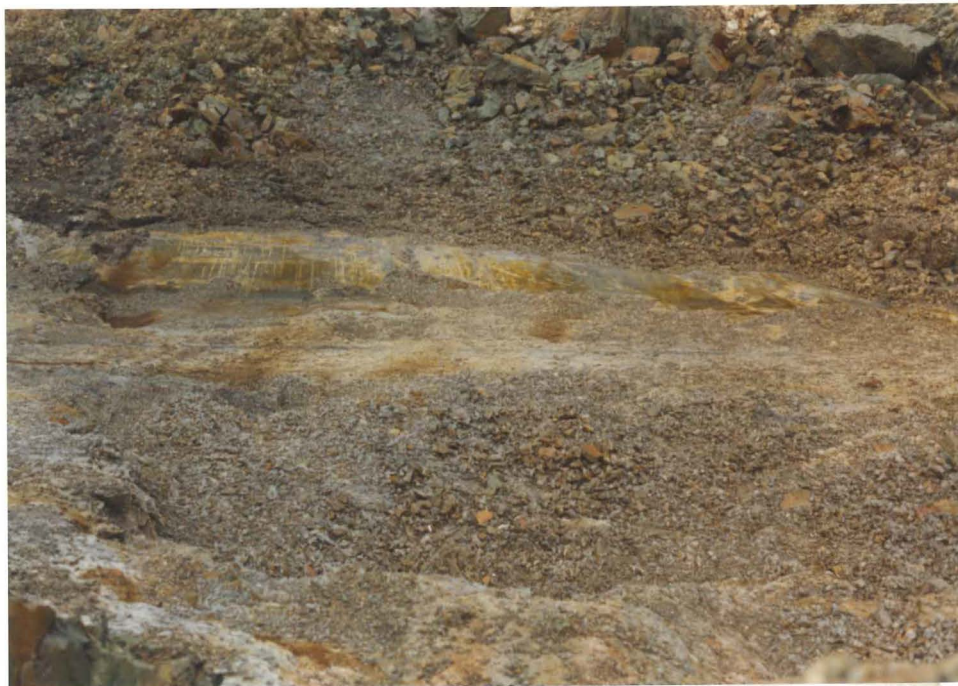
Figure 4.2: Slickensides on joint surface Fig. 4.1 looking southwards and down onto the joint surface.

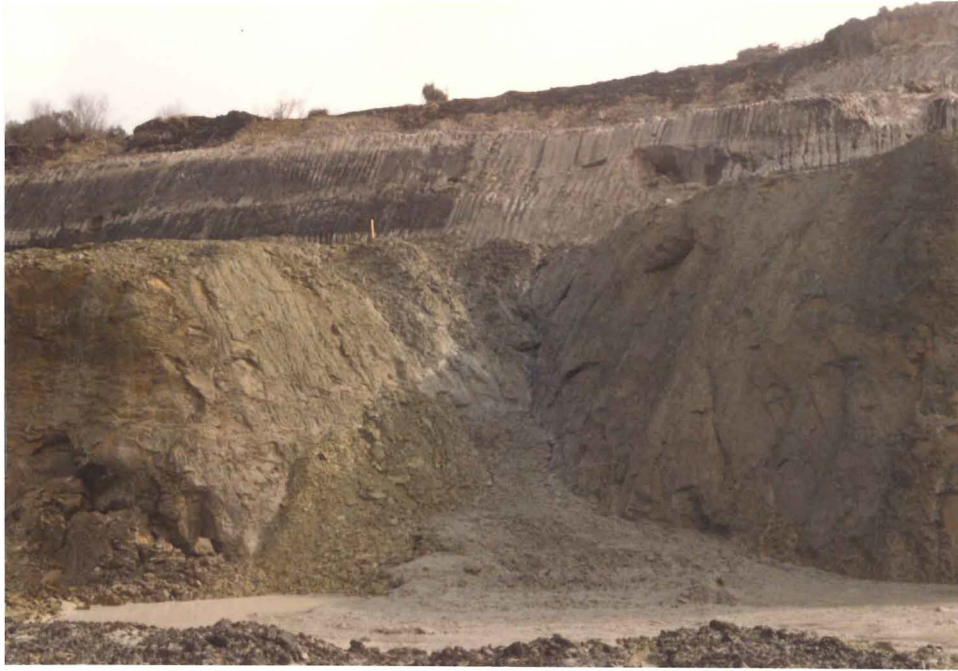
Figure 4.5: Wedge failure in Glen Afton Claystone resulting from sliding along line of intersection of two defect planes. Batter face orientation is towards 130 at 80, batter height is 9m. (G.R 332880mE 623190mN) viewing North.

Field observations in Weavers Opencast Mine suggest that wedge failures as defined above occur most frequently in batters with an orientation of $130^\circ/80^\circ$, resulting from the intersection of defect types A and C and A and D. These observations are supported by

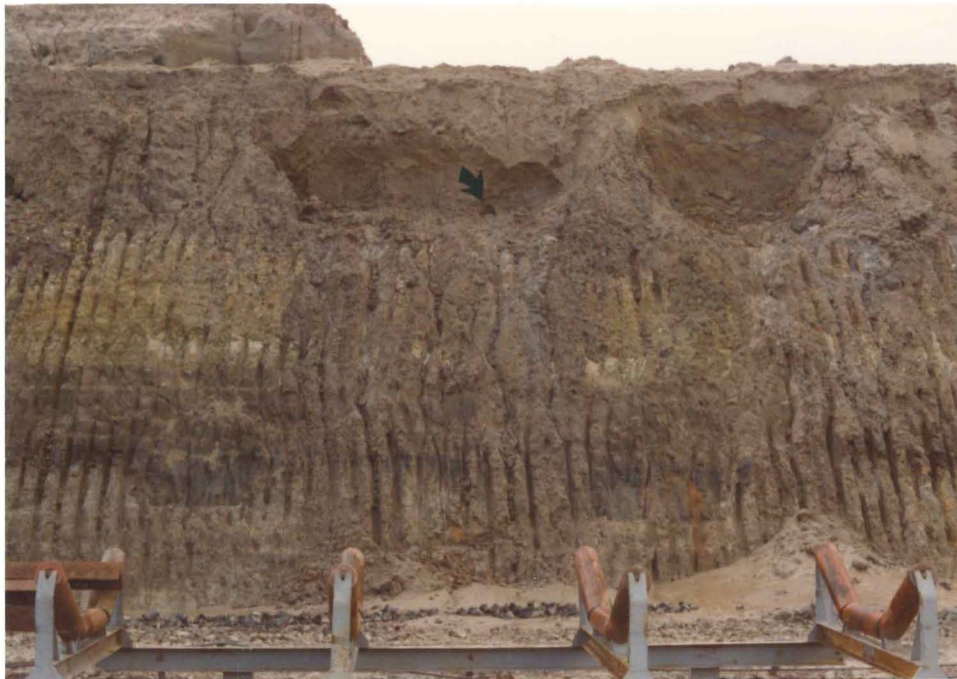
Figure 4.9: Piping failure in Hinuera Formation sands overlying Whangamarino Formation silty clays. Piping failure indicated by arrow.

Piping failures observed in the Taupo Pumice Alluvium and Hinuera Formation result from entrainment and erosion of material from the batter face. Figure 4.9 illustrates the development of piping failures in the Hinuera Formation. Piping failures develop as a result of high seepage pressures in the silty sands where they overlie the thin impermeable silty clay layers in the Hinuera Formation. Pore pressure results in the disaggregation of sand and silt grains and their entrainment and erosion from the batter face. Continued erosion at critical localities in the batter face undermines the overlying materials and results in the formation of steep walled semi circular cavities at the batter surface. Although failures of this type are progressive and involve small volumes of material, the rate of batter erosion and subsequent retreat can be relatively rapid.

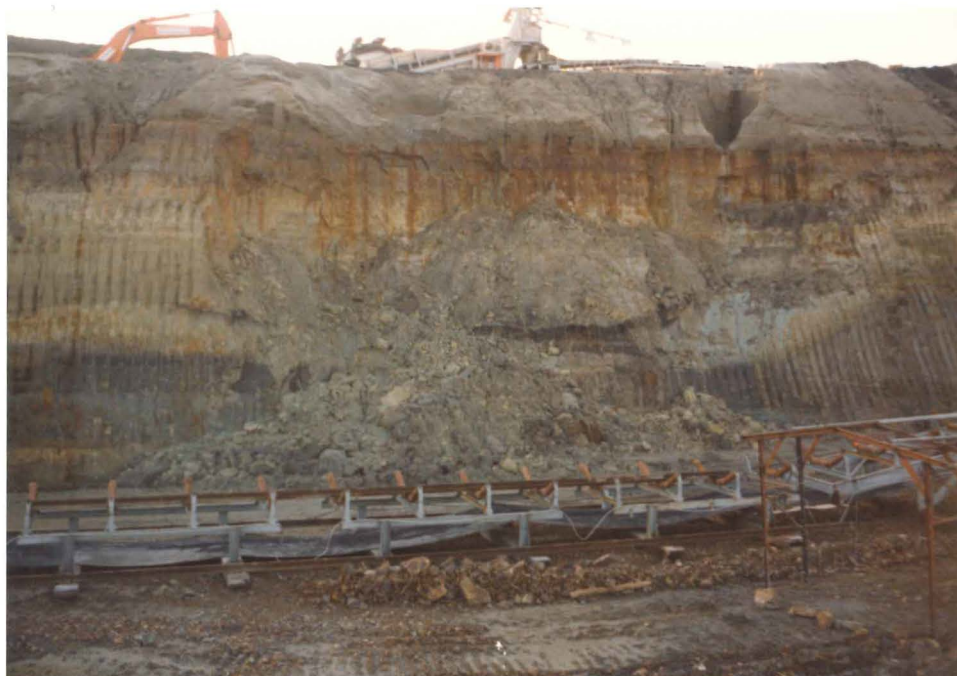
Figure 4.11: Earth fall in Whangamarino Formation,
(G.R. 333465mE 623575mN) viewing north.
Batter height is 8m, volume of instability
is c.100 cu.metres.

A second failure of this type was observed in the Whangamarino Formation (Figure 4.11) which occurred at approximately the same time as the batter failure in Figure 4.10. Failure involved approximately 100-200m³ of material from a paleochannel incised into the underlying silty clays. A steep batter angle and seepage pressures from the batter face are again assumed to be the main contributing factors. No further instability was associated with either of these failures after the initial movement.

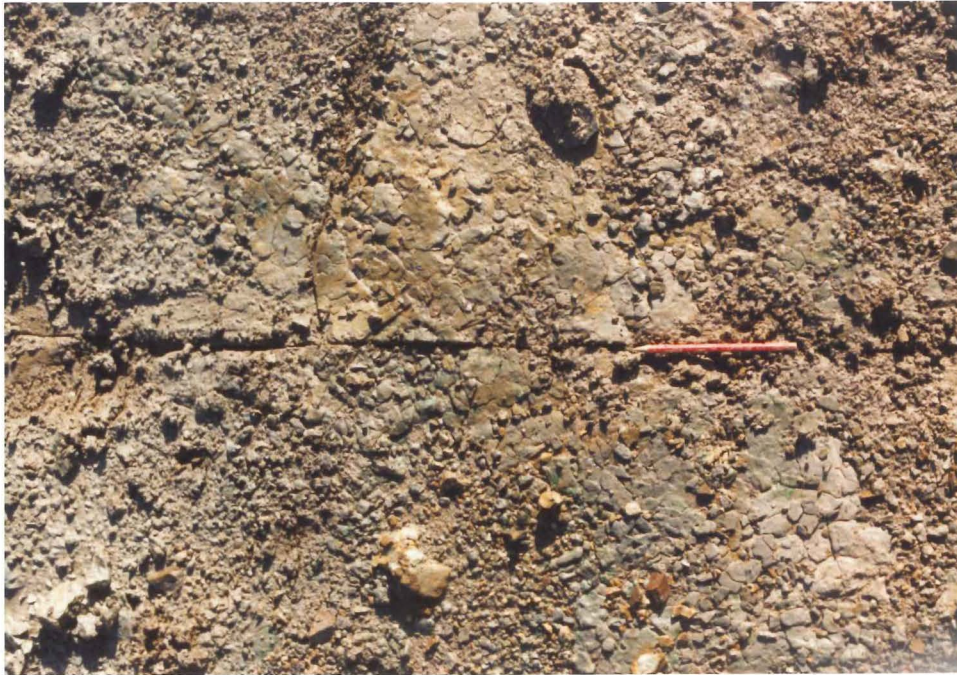
Figure 4.12: Sub vertical joint in Whangamarino Formation striking parallel to mine highwall exposed in bench surface c. 10m from batter edge. (G.R. 333380mE 623505mN) .

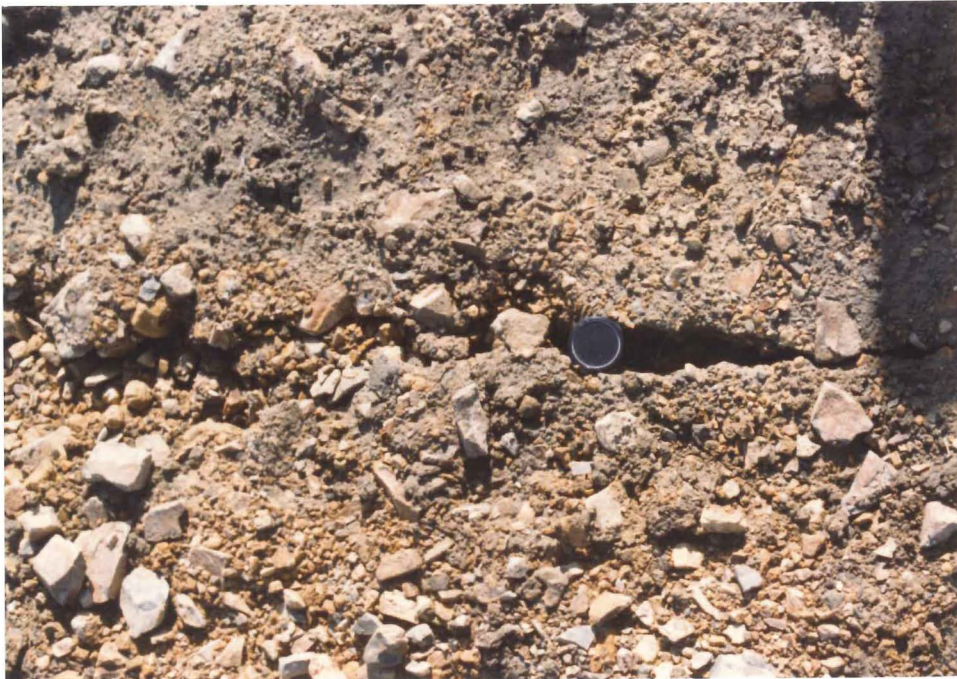
Figure 4.13: Subvertical joint in Whangamarino Formation 2m from batter edge. Joint aperture is opening up due to lateral stress release.

The development of toppling failures is outlined in Figures 4.12-4.15 . Initially the joints are tight (Figure 4.12). However with the excavation of the batter face, relaxation of the soil mass occurs and joint sets open up (Figure 4.13) , resulting in the development of a tension crack parallel to the face (Figure 4.14) Progressive overbalancing of the block material occurs, until the centre of gravity is exceeded and failure occurs (Figure 4.15). Attempts have been made to stabilise joint blocks in the vicinity of the bucketwheel conveyor belt by placing wire netting across the bench surface and batter face, however these attempts have been largely unsuccessful.

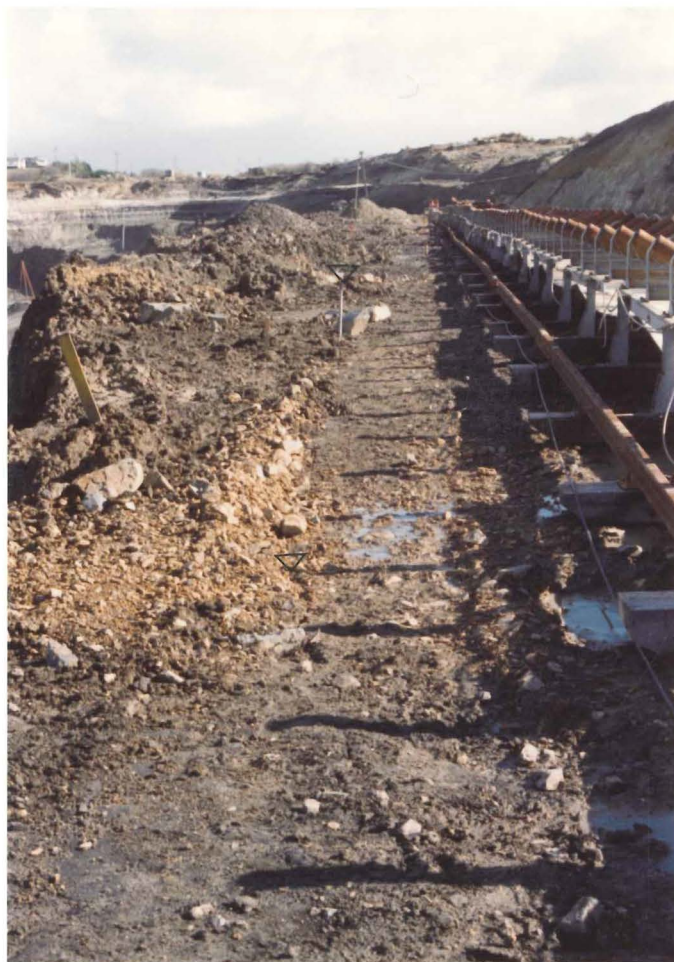
Figure 4.14: Sub-vertical joint in Fig.4.13 illustrated in relation to batter edge and conveyor belt. Trace of joint in bench surface is indicated by arrow and spade.

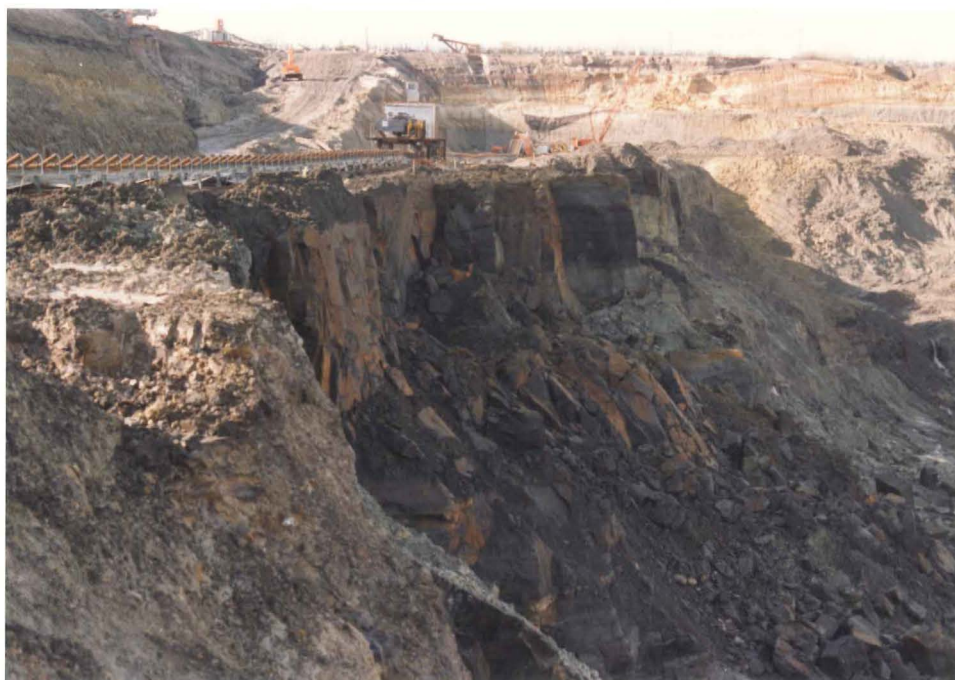
Figure 4.15: Toppling Failure in Tauranga Group.
(G.R.333330mE 623480mN) viewing east.

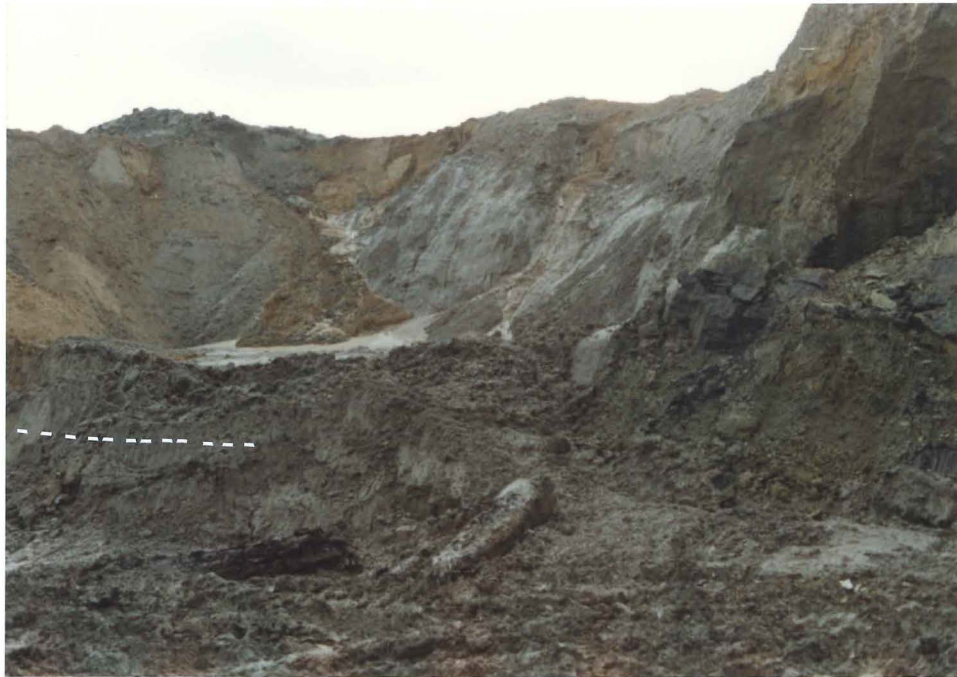
Figure 4.17: Sliding failure in Whangamarino Formation in SW batter slopes, April 1987. Failure involved c.6000 cu. metres along 40-50m of batter face. Batter height is 8m. Position of Te Kuiti-Tauranga Group indicated by dotted line.
(G.R. 332880mE 623270mN) viewing north.

- 1) The water apparent in Figure 4.17 is a result of discharge from the upper aquifer into a drain adjacent to the slide area. It is assumed from this that water infiltration into the lower Tauranga Group sediments may have been a factor contributing to the instability.
- 2) The location of the unconformity contact is indicated and suggests that shearing occurred on or close to the unconformity surface.
- 3) A significant factor involved in the failure appears to have been the sub vertical (to slightly overhanging) batter face cut by the bucketwheel (Figure 4.18).
- 4) The variability in shear strength of Tauranga Group materials along the unconformity surface is indicated by

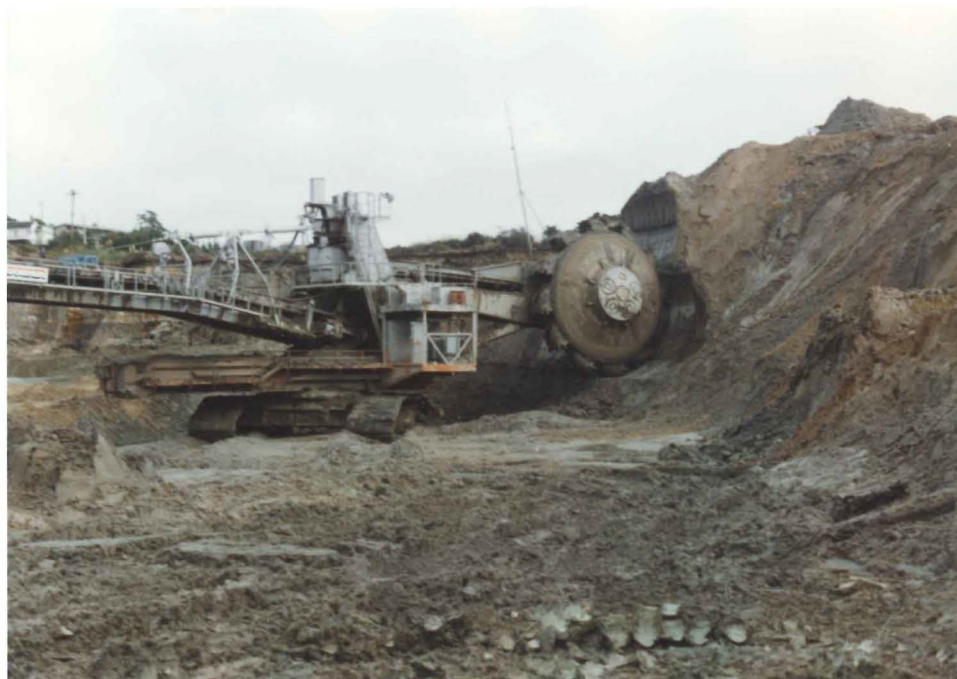
Figure 4.18: Bucketwheel excavator in operation adjacent to slide area (Fig. 4.17), note steep angle of cut batter face.
